CERTIFICATION EVALUATION AND SCOPING STUDY REPORT

Montour Falls Flood Damage Reduction Project
Location: Montour Falls, Schuyler County, New York
NYS DEC Region 8, and USACE Buffalo District

Schnabel Reference 21C25005.00
August 17, 2021 (Rev. September 10, 2021)

**CERTIFICATION EVALUATION AND SCOPING STUDY REPORT
MONTOUR FALLS FLOOD DAMAGE REDUCTION PROJECT
VILLAGE OF MONTOUR FALLS, NEW YORK**

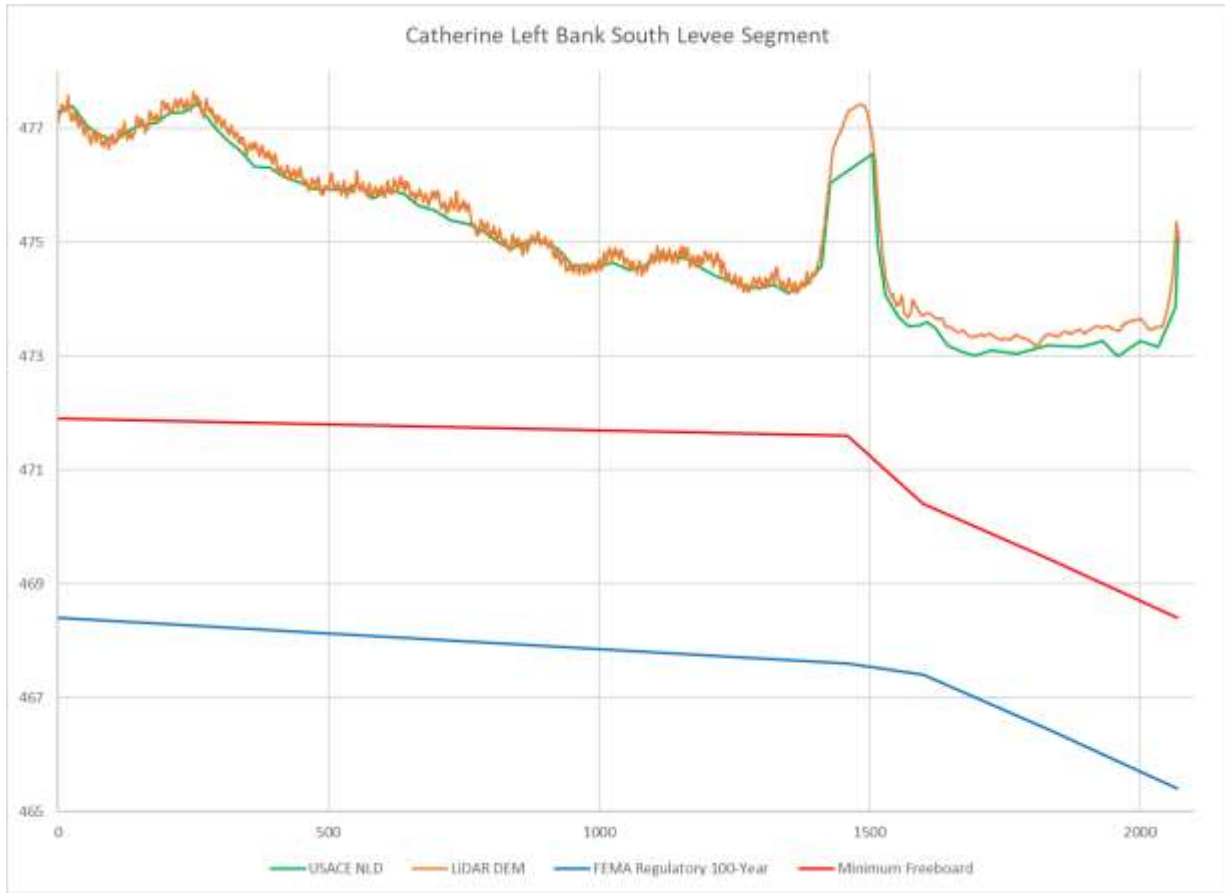
Figure 1.3: Levee Profile for Catharine Left Bank South Levee Segment

The NLD and DEM data indicate that the existing Catharine Left Bank South Levee Segment has crest elevations that generally exceed the minimum freeboard requirements by approximately two (2) to five (5) ft.

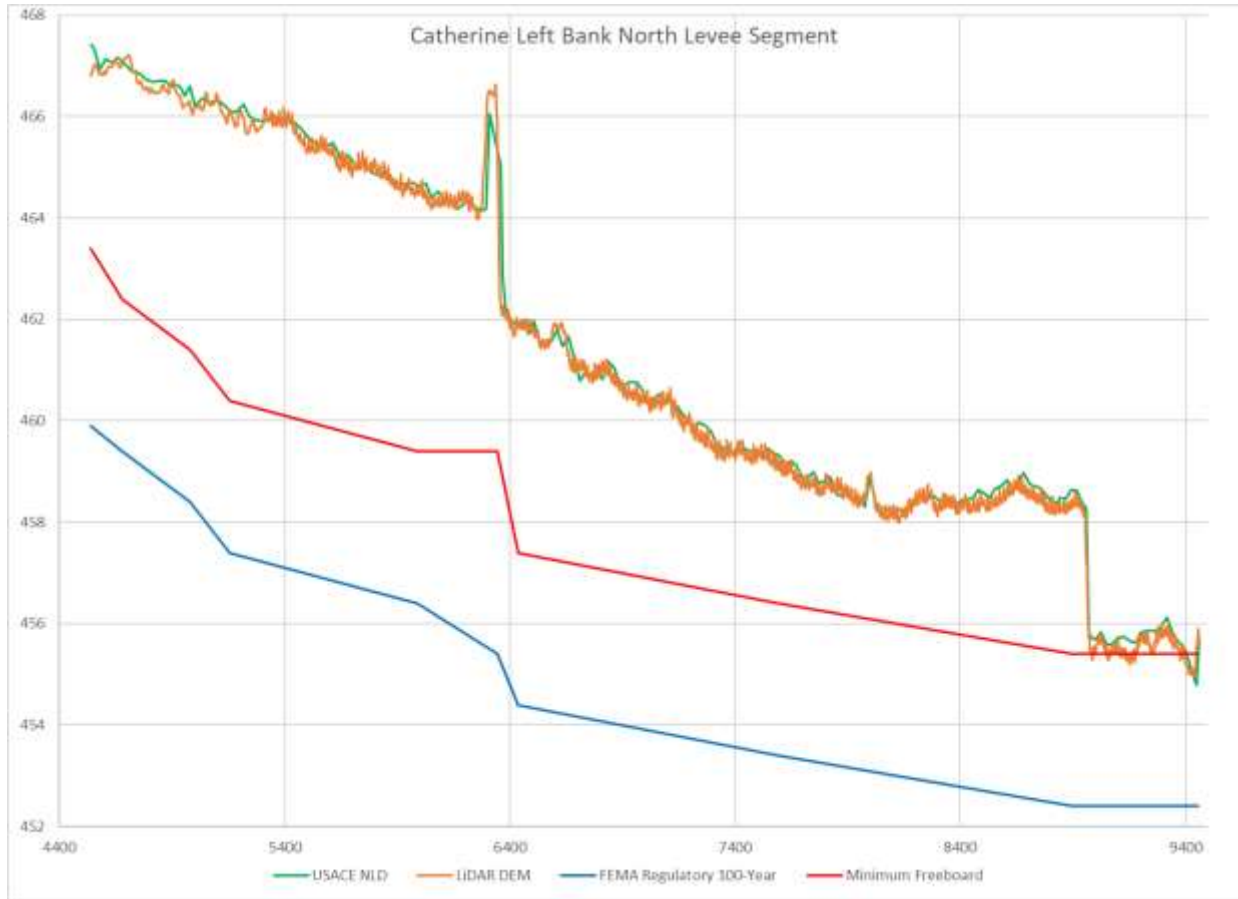
Figure 1.4: Levee Profile for Catharine Left Bank North Levee Segment

The NLD and DEM data indicate that the existing Catharine Left Bank North Levee Segment has crest elevations that generally exceed the minimum freeboard requirements by approximately two (2) to five (5) ft. However, the most downstream portion which was constructed as a levee extension in 1953 may have some minor areas that are below the minimum freeboard requirement.

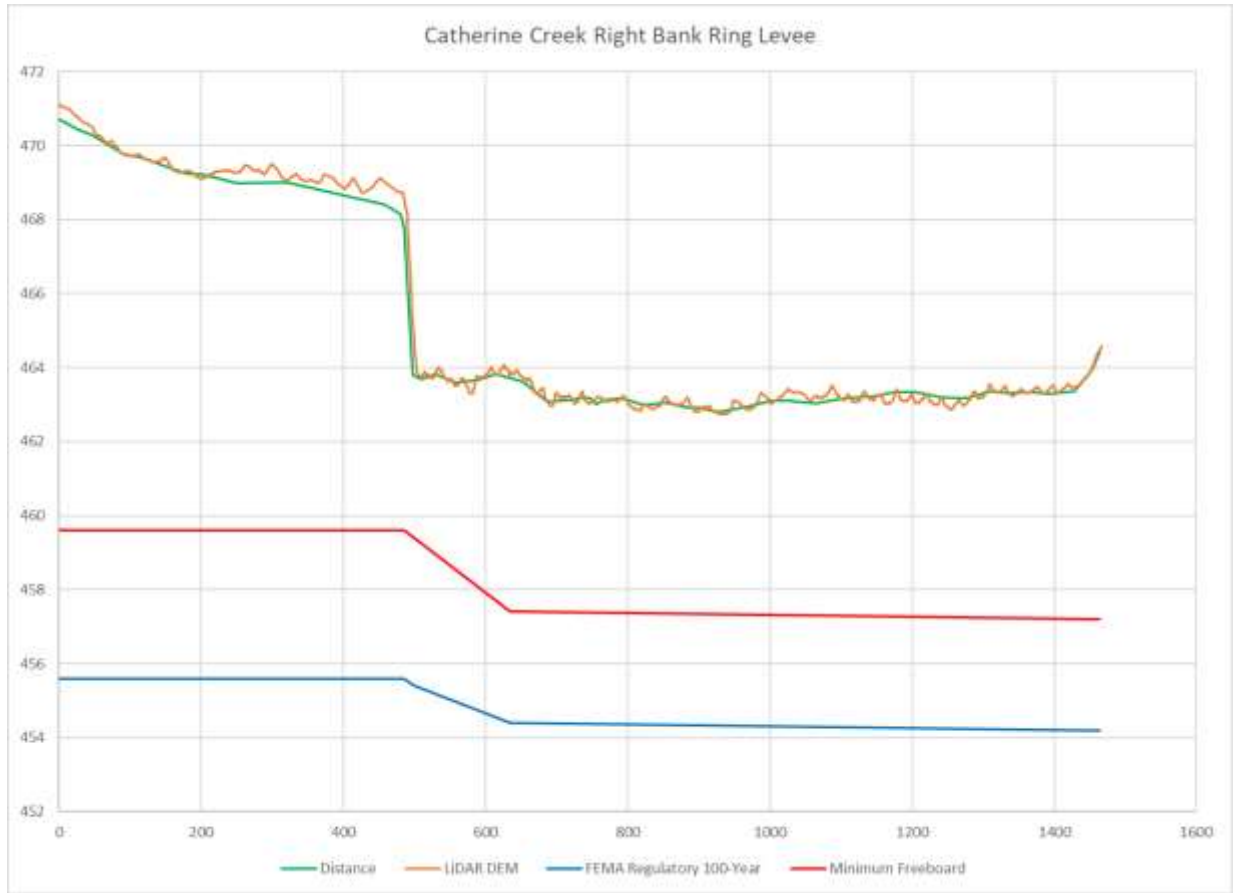
Figure 1.5: Levee Profile for Catharine Right Bank Ring Levee

The NLD and DEM data indicate that the existing Catharine Right Bank Ring Levee has crest elevations that generally exceed the minimum freeboard requirements by approximately four (4) to ten (10) ft.

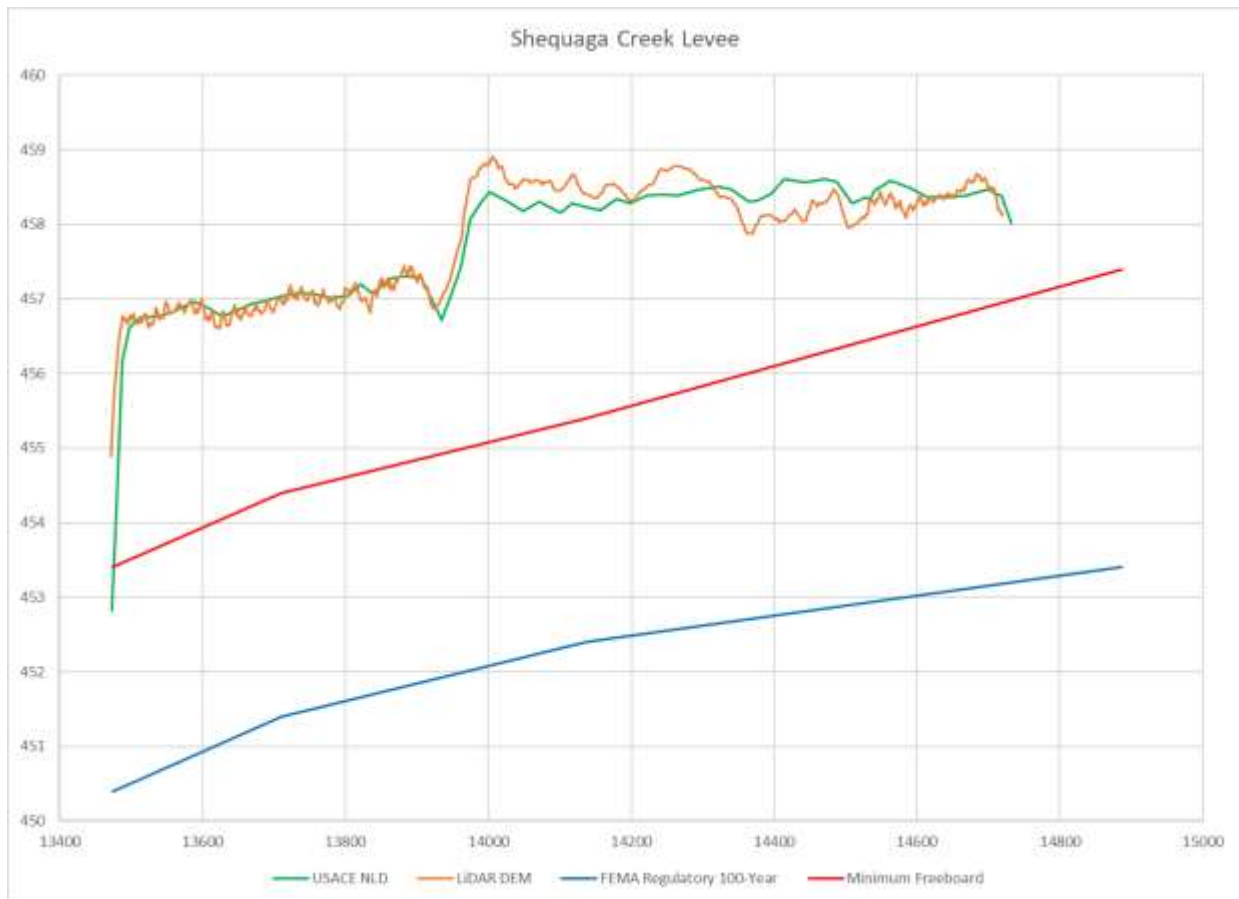
Figure 1.6: Levee Profile for Shequaga Creek Levee

The NLD and DEM data indicate that the existing Shequaga Levee has crest elevations that generally exceed the minimum freeboard requirements by approximately two (2) to three (3) ft.

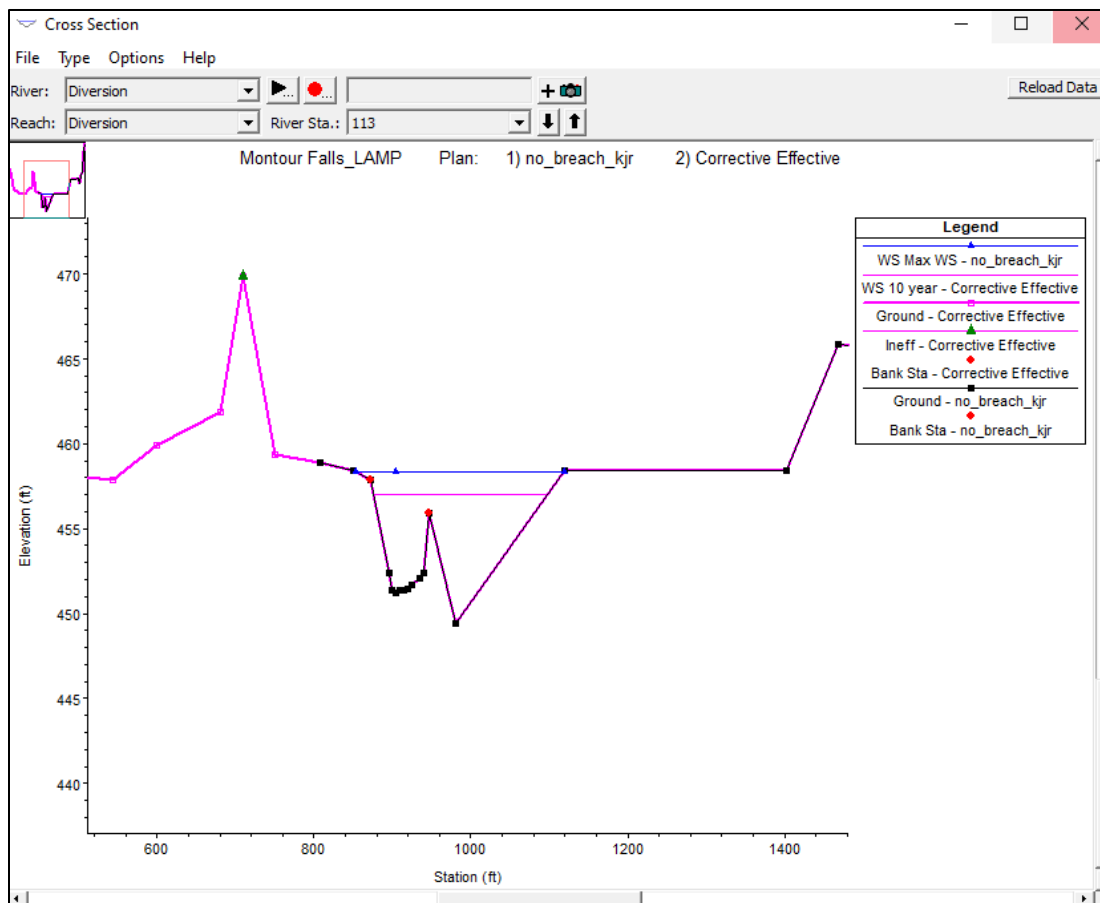
Figure 1.9: 100-Year WSEL Comparison at Cross Section 113

Overall, the revised model generally predicted higher water surface elevations for the 100-Year Base Flood Event of approximately 0.5 to 1.5 ft. This is presumably due to the utilization of unsteady flow data in the revised model geometry for inflows at Catharine Creek, Havana Glen, Catlin Creek, and Shequaga Creek. Even if the higher elevations are reasonable, the excess freeboard identified in Figures 1.3 – 1.6 would indicate that the existing levee system likely meets minimum freeboard requirements. The revised FEMA modeling was also used to assess potential velocities that the levees may be subjected to. Peak velocities for the Sound Reach with No Breaches are presented in Figure 1.10. The Left Bank South segment is predicted to have velocities less than 2 ft/s, which would generally be non-erosive. The Left Bank North segment would likely experience higher velocities of approximately 5 ft/s upstream of Clawson Blvd. The Shequaga Levee segment is predicted to experience the highest velocities of around 6 ft/s.

If the Village decides to move forward with Phase 2 of the accreditation process, we believe that refined hydraulic modeling will need to be performed to better ascertain levee freeboard and erosion stability. We would recommend a full 2-Dimensional model that better utilizes the high resolution DEM data that is available. The model should also utilize refined flow data from the recommended hydrologic modeling of the watershed.

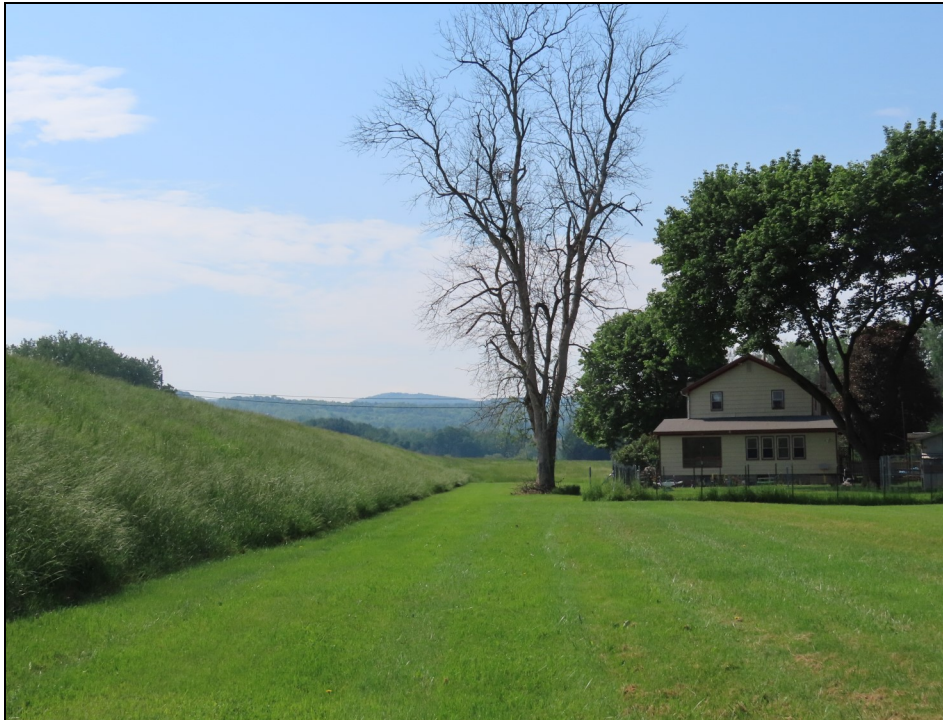
PHOTO 4

Note dead tree measured 18
from toe of slope and therefore
not classified as an
encroachment .

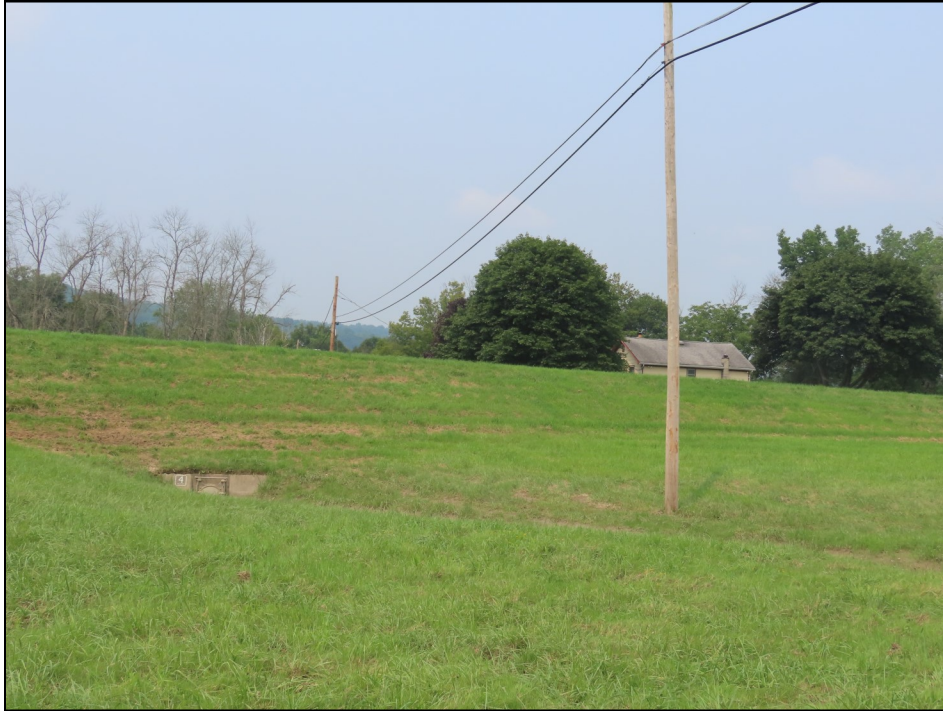
PHOTO 7

Note encroachment of utility lines running across the levee.

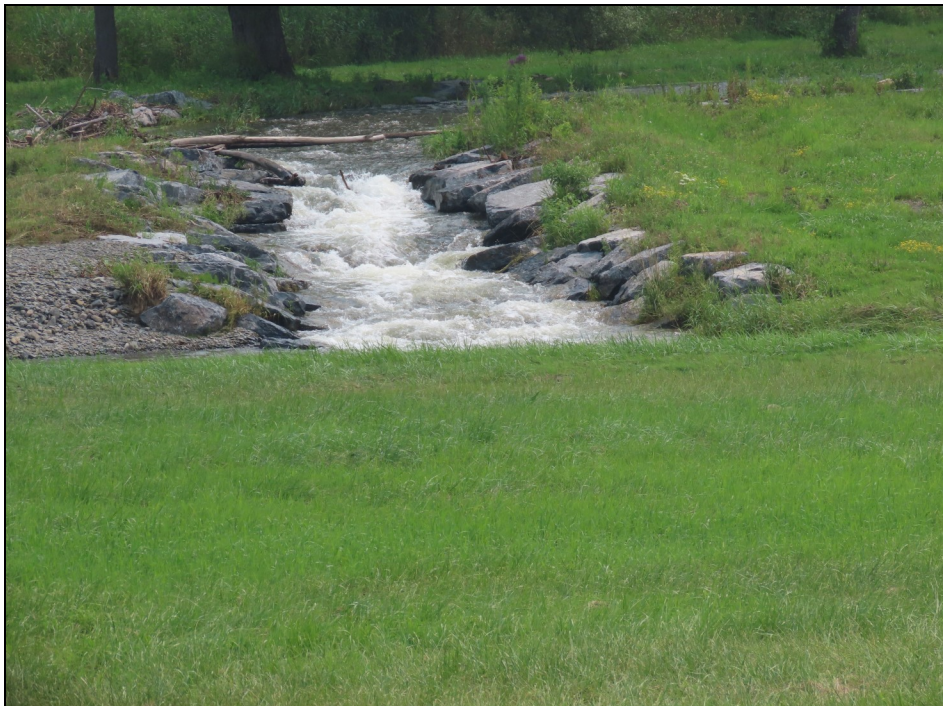
PHOTO 8

Confluence of Caitlin Mill Creek and Catharine Creek Diversion channel. Large rip rap riffle approved alteration.

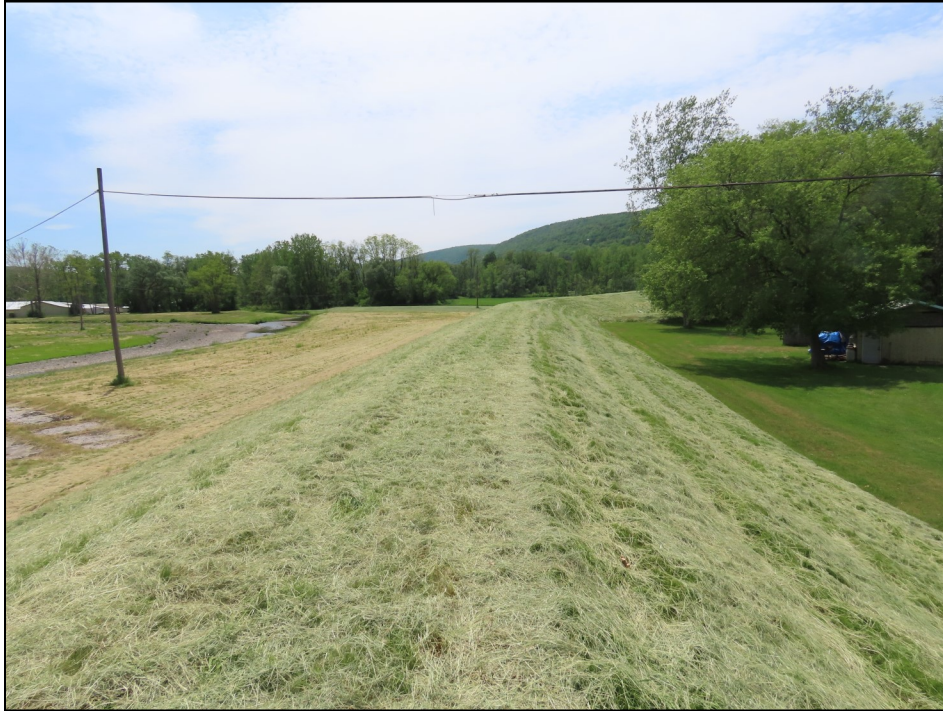
PHOTO 9

Note utility lines running across the levee and utility pole in the channel. Utility lines are a minor encroachment. Poles are spaced sufficiently far apart from toe of embankment.

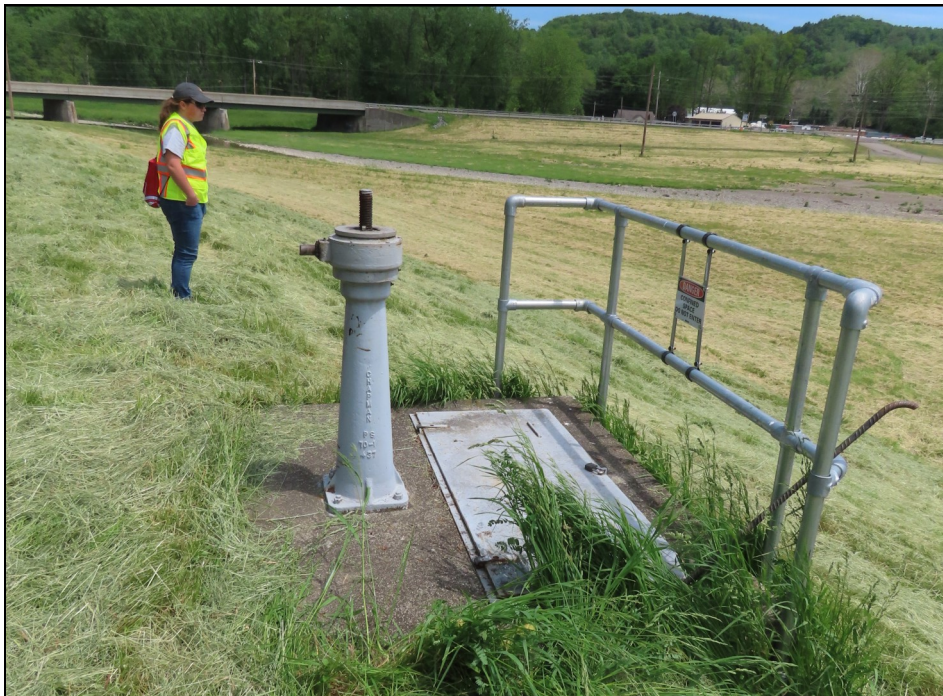
PHOTO 10

Culvert #5 manhole station. Conduit flow control is via 24" sluice gate.

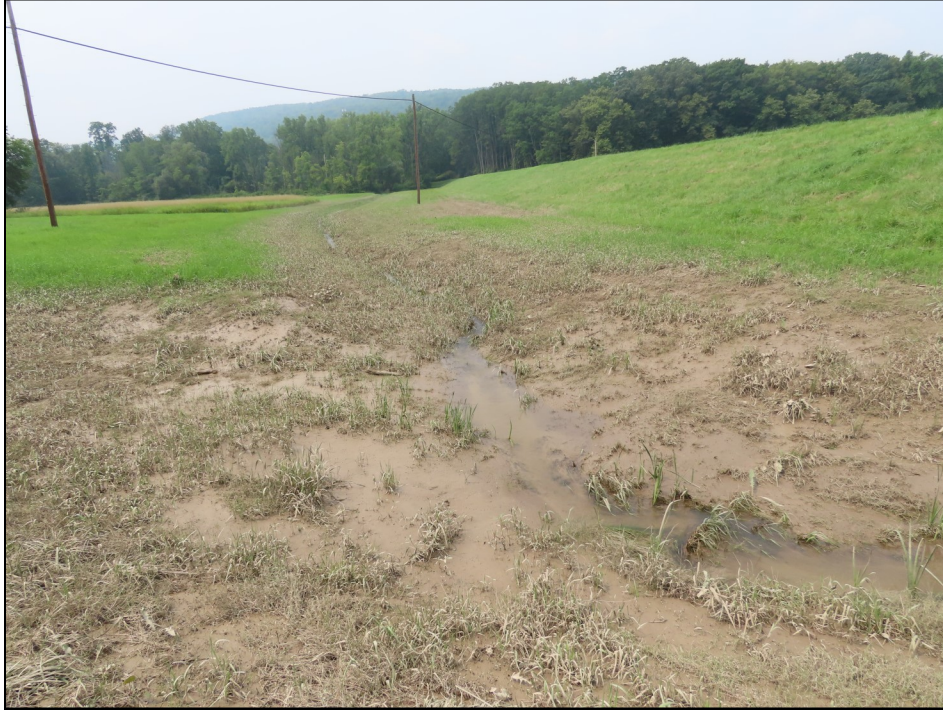
PHOTO 13

Note: Utility line encroachment. Silt on grass is from temporary impoundment of runoff at flood gate #5.

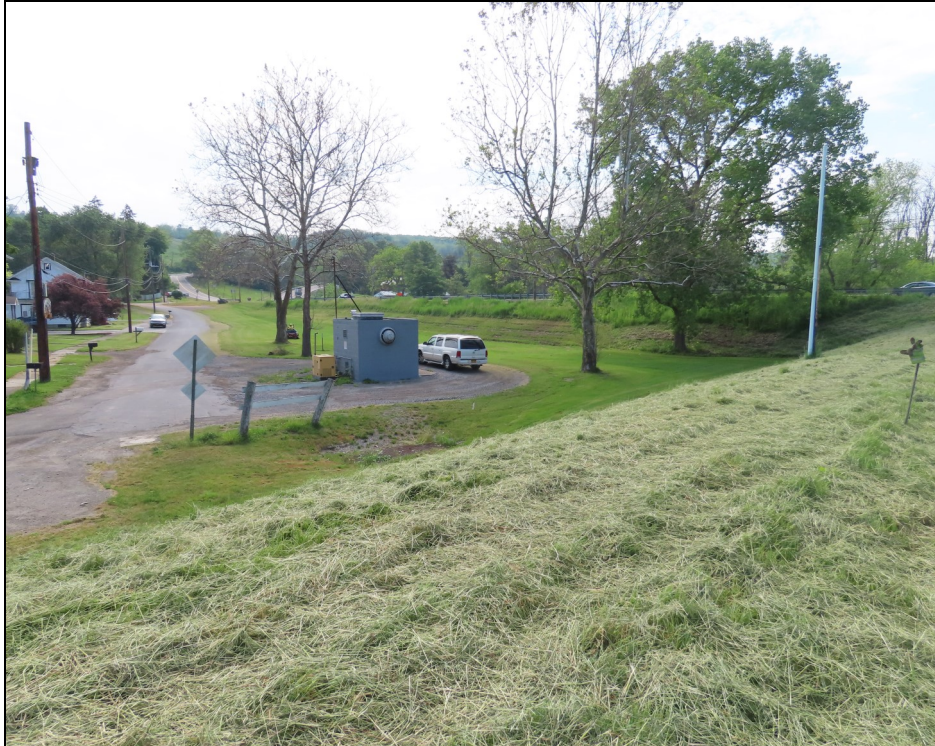
PHOTO 16

Note: Small utility building is a sewage pump station. On crest of dam is a 4" dia. sewage vent riser, and grated culvert inlet is located at the toe of the levee embankment

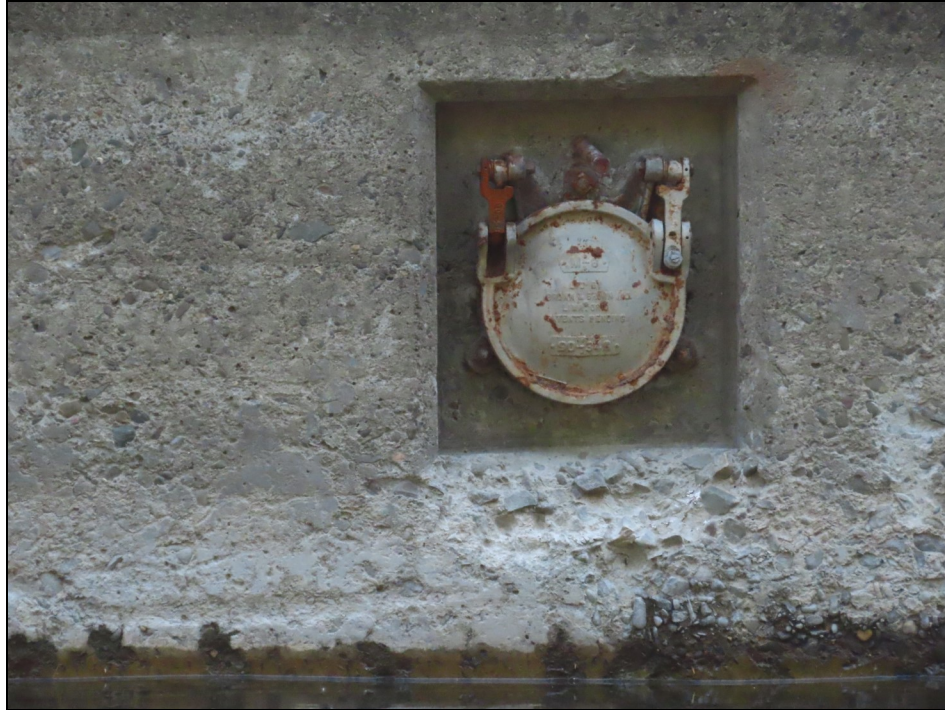
PHOTO 22

One of several flap gates on the stilling basin providing drainage from behind the landside of the wall.

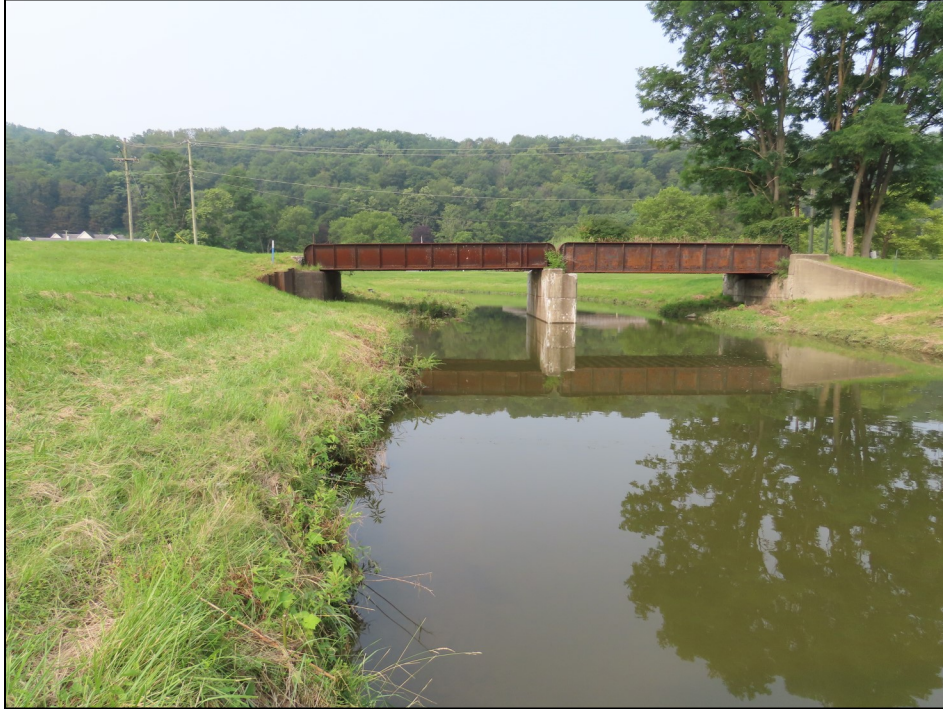
PHOTO 27

Abandoned railroad bridge spanning Shequaga Creek.

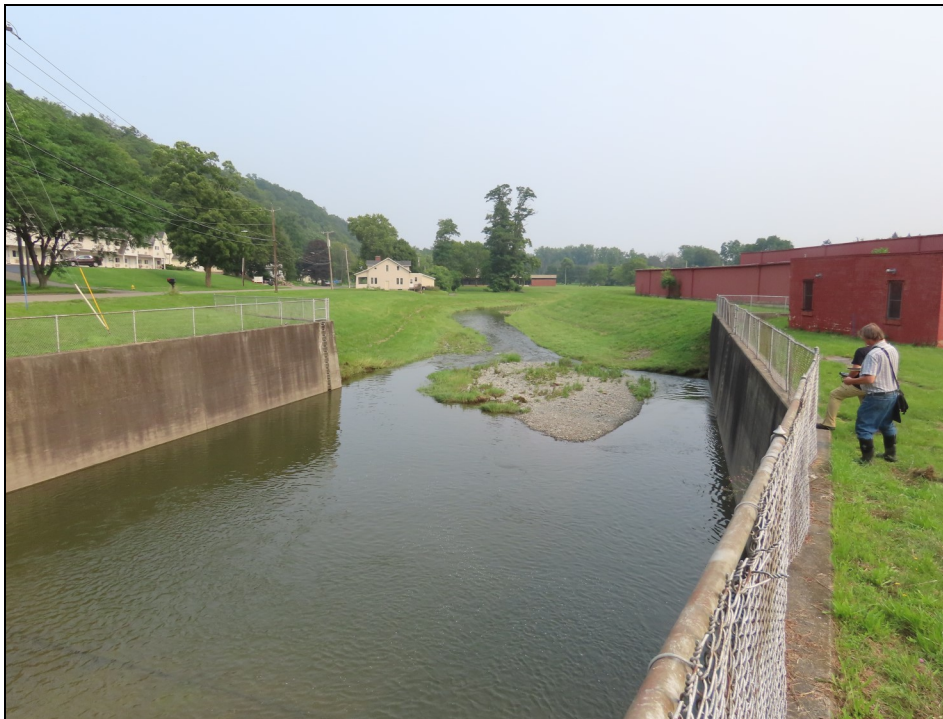
PHOTO 28

Note shoaling at terminus of stilling basin. Shoal should be removed as it is creating toe scour on right levee embankment.

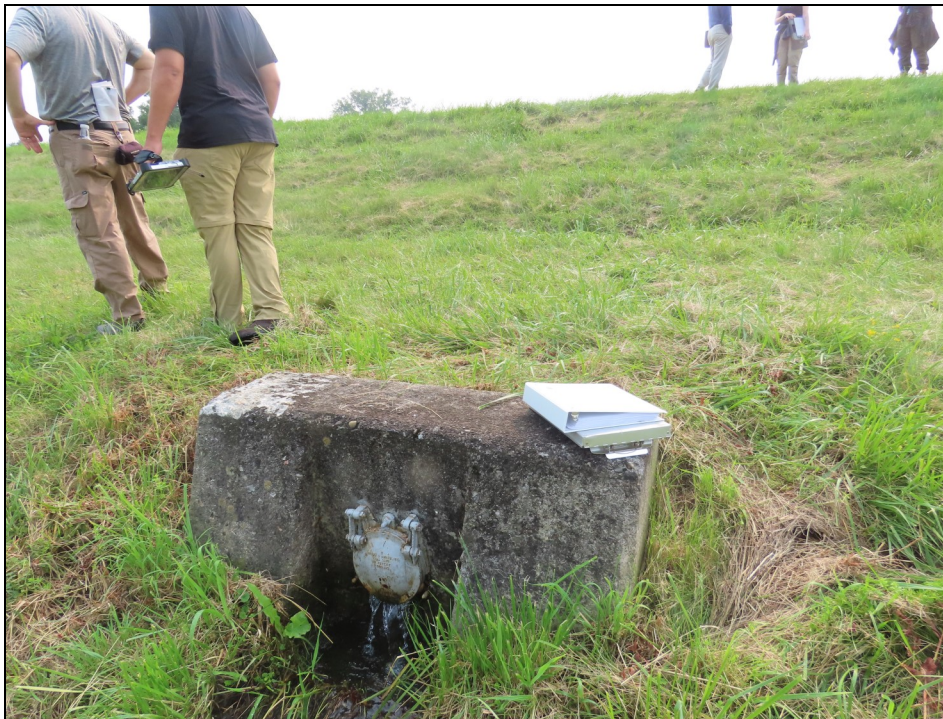
PHOTO 30

CS-1 one of five flap gates on the Shequaga Creek levee.

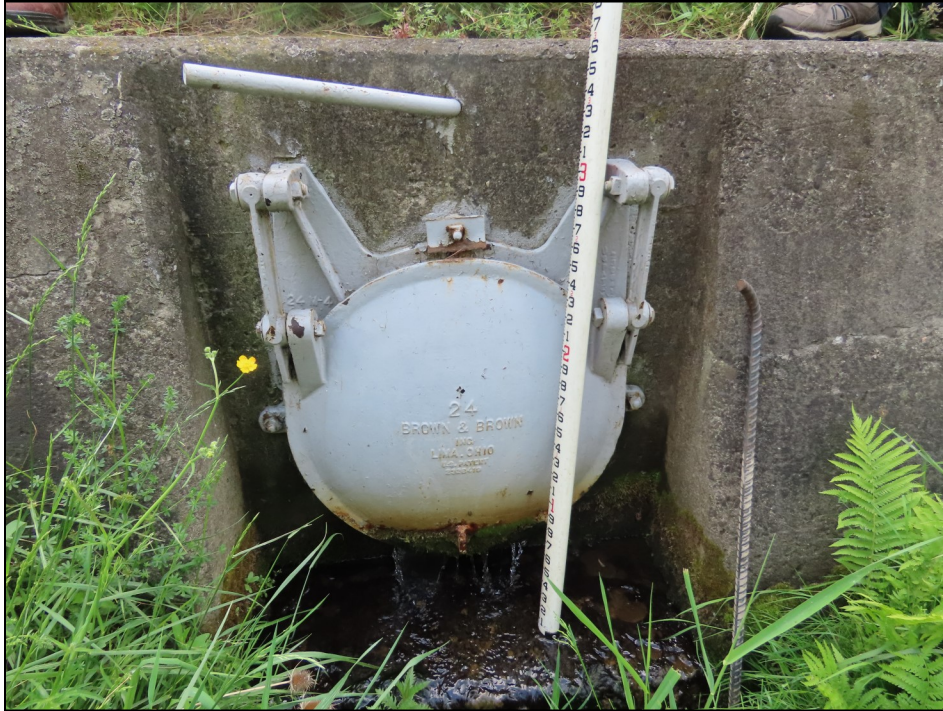
PHOTO 31

CS-2 one of five flap gates on the Shequaga Creek levee.

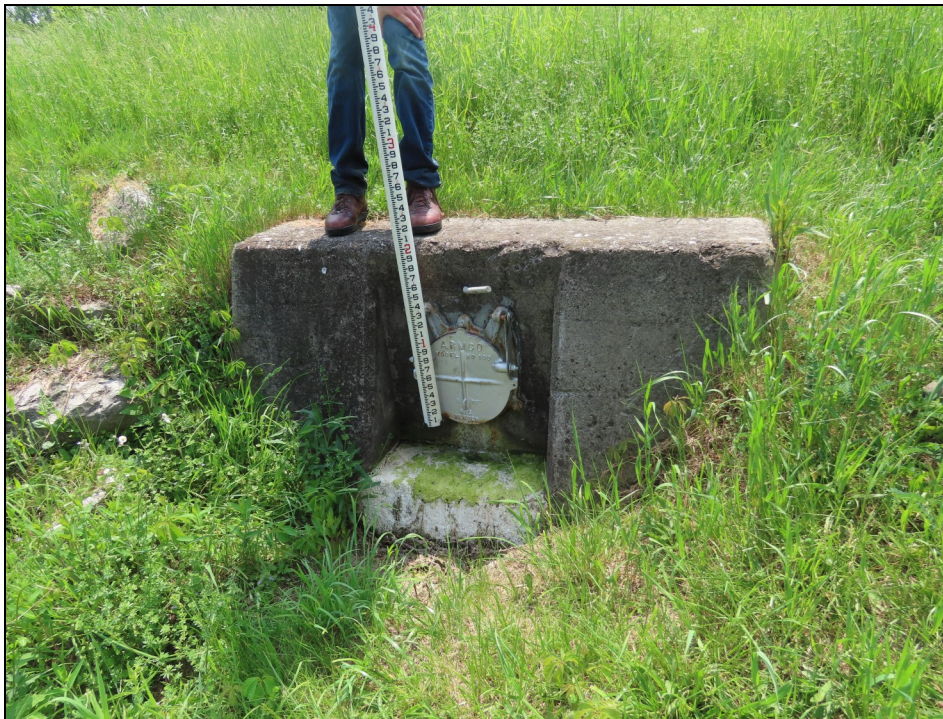
PHOTO 32

CS-3 one of five flap gates on the Shequaga Creek levee.

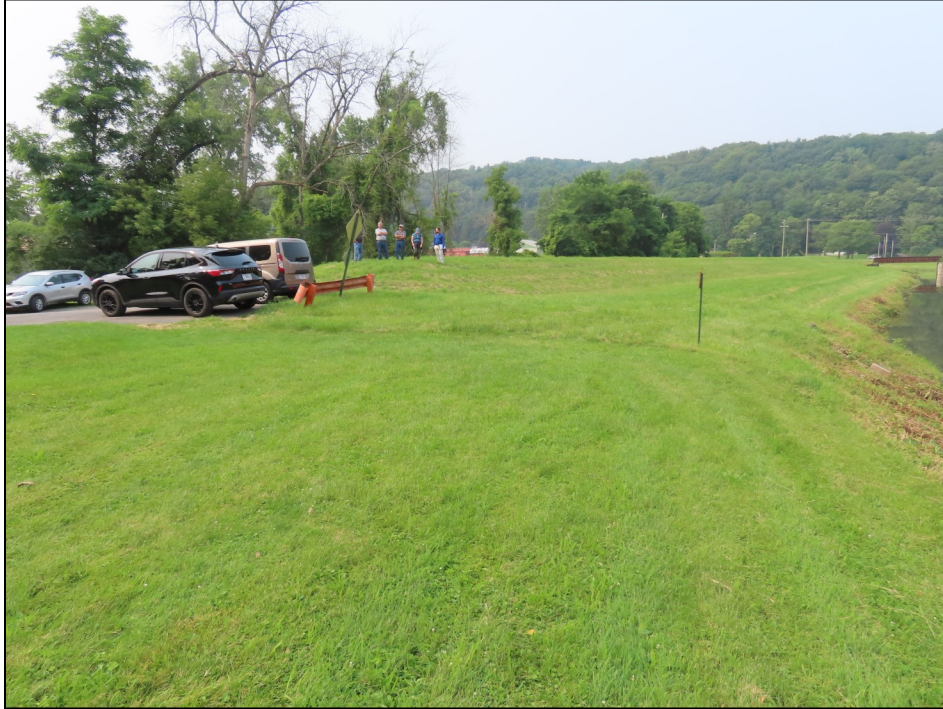
PHOTO 33

Note this section of levee is benched.

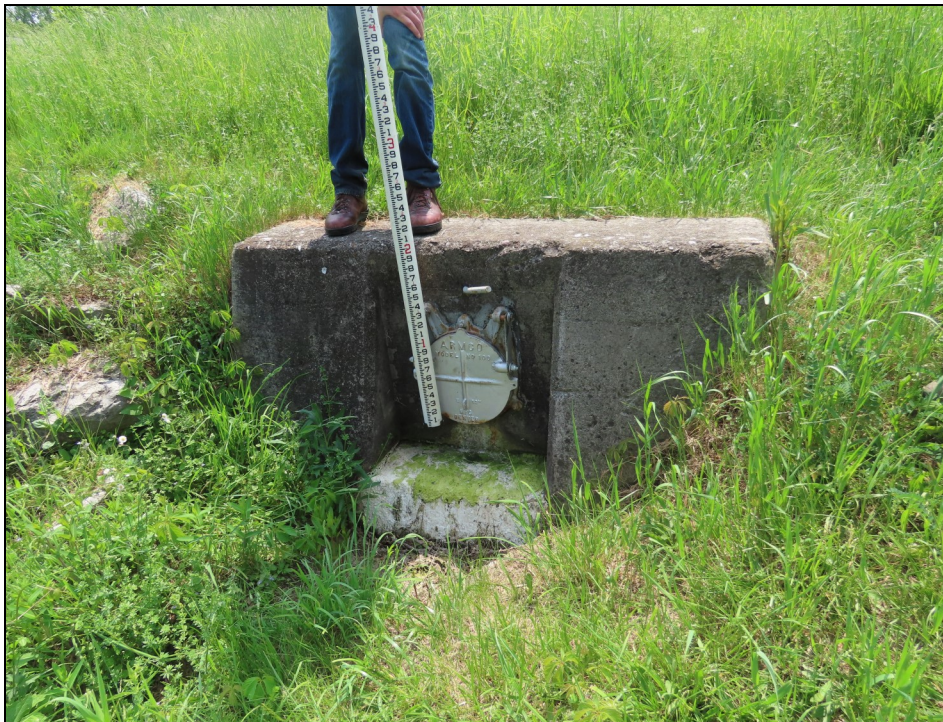
PHOTO 32

CS-5 one of five flap gates on the Shequaga Creek levee.
