CERTIFICATION EVALUATION AND SCOPING STUDY REPORT

Montour Falls Flood Damage Reduction Project
Location: Montour Falls, Schuyler County, New York
NYS DEC Region 8, and USACE Buffalo District

Schnabel Reference 21C25005.00
August 17, 2021 (Rev. September 10, 2021)

**CERTIFICATION EVALUATION AND SCOPING STUDY REPORT
MONTOUR FALLS FLOOD DAMAGE REDUCTION PROJECT
VILLAGE OF MONTOUR FALLS, NEW YORK**

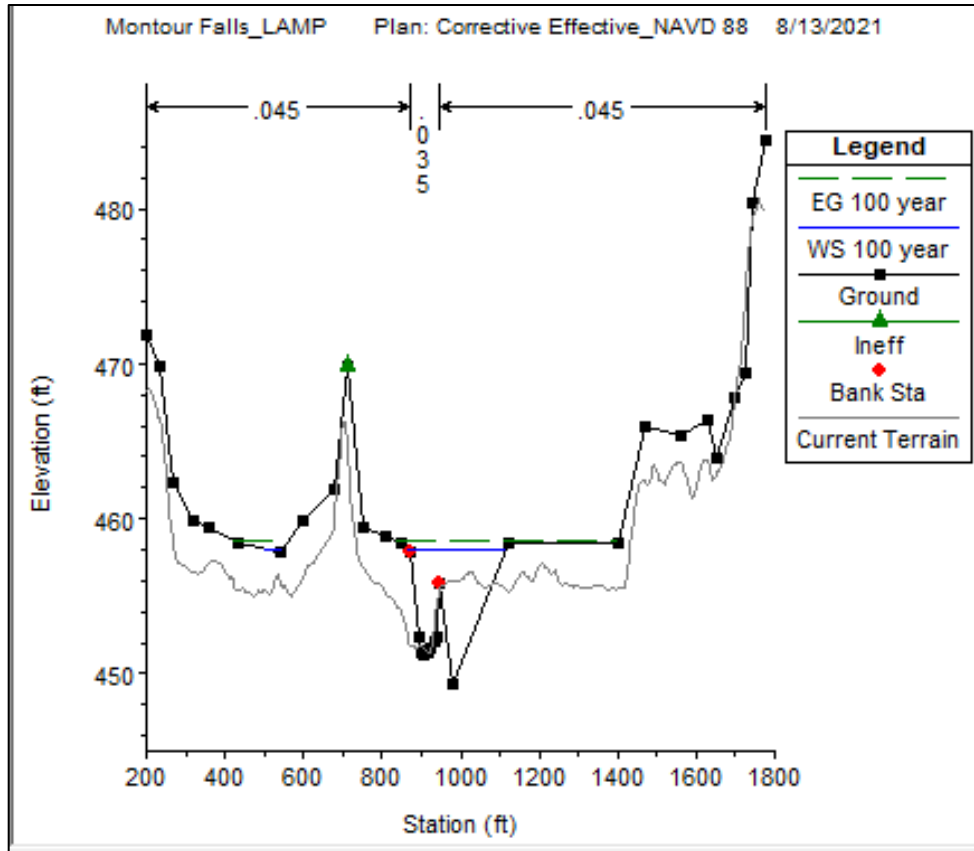
Figure 1.8: HEC-RAS Cross Section 113 and DEM Terrain Data

Schnabel received the HEC-RAS model files from FEMA and reviewed them for applicability for the accreditation process. Based on this review, it looks like the model was developed by utilizing the regulatory 1D model converted to NAVD 1988 vertical datum and then represented the area protected by the levee system as 2D flow areas connected to the 1D model through lateral structures representing the various levee segments. One item of concern is that while the 2D flow areas utilized the 2014 LiDAR DEM data, it appears that the 1D cross sections for Catharine Creek, the Diversion Channel and Shequaga Creek retained cross section data from the FEMA regulatory hydraulic model. In some locations, the cross-section data correlated well with the DEM data, but at a majority of the cross-sections, there were significant differences. An example is at Cross Section 113 of the Diversion Channel presented below.

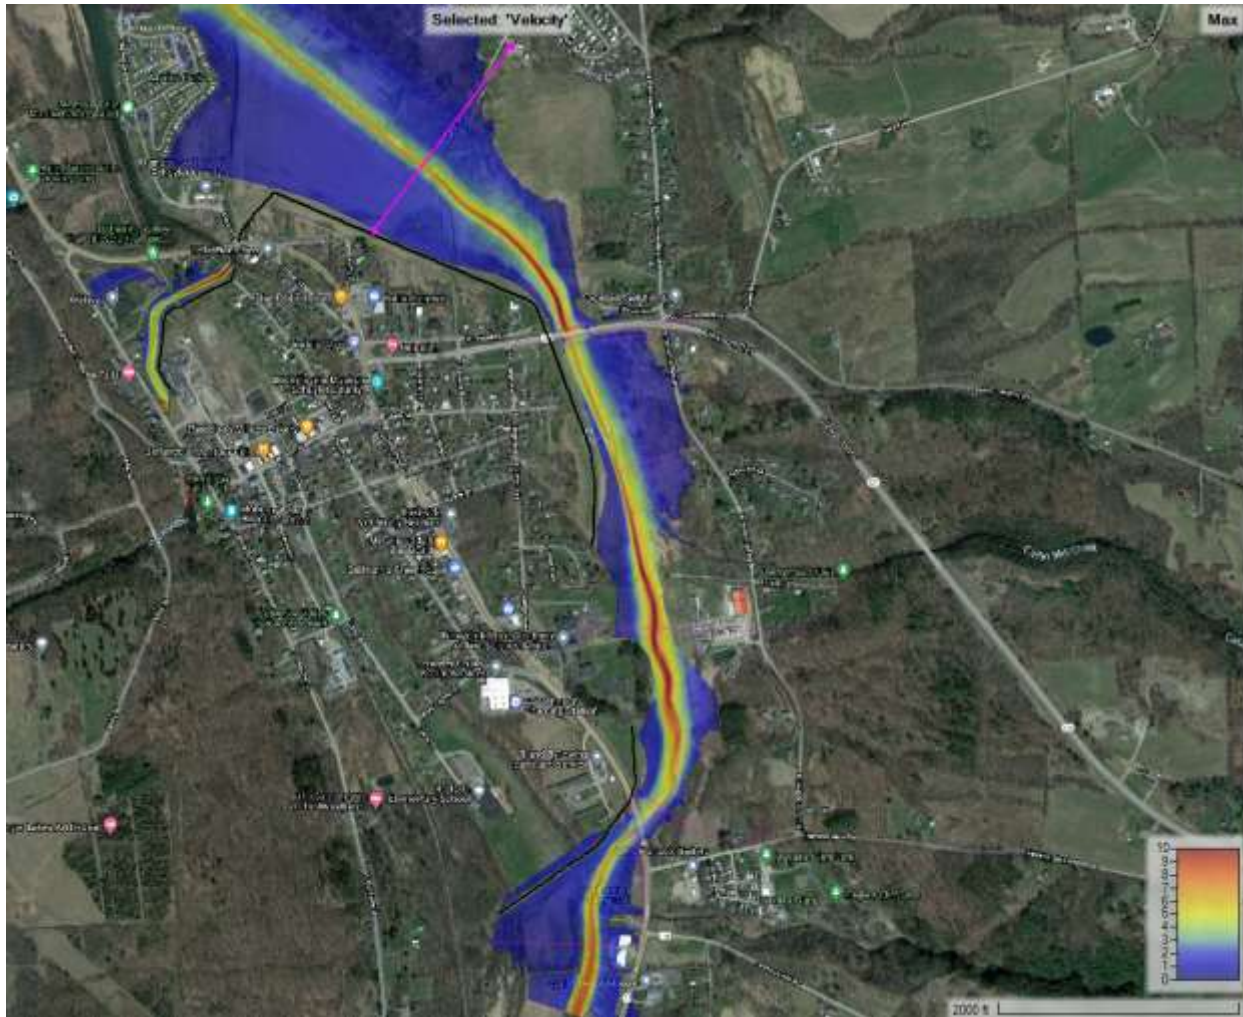
Figure 1.10: 100-Year Peak Velocities

Overall, the revised model generally predicted higher water surface elevations for the 100-Year Base Flood Event of approximately 0.5 to 1.5 ft. This is presumably due to the utilization of unsteady flow data in the revised model geometry for inflows at Catharine Creek, Havana Glen, Catlin Creek, and Shequaga Creek. Even if the higher elevations are reasonable, the excess freeboard identified in Figures 1.3 – 1.6 would indicate that the existing levee system likely meets minimum freeboard requirements. The revised FEMA modeling was also used to assess potential velocities that the levees may be subjected to. Peak velocities for the Sound Reach with No Breaches are presented in Figure 1.10. The Left Bank South segment is predicted to have velocities less than 2 ft/s, which would generally be non-erosive. The Left Bank North segment would likely experience higher velocities of approximately 5 ft/s upstream of Clawson Blvd. The Shequaga Levee segment is predicted to experience the highest velocities of around 6 ft/s.

If the Village decides to move forward with Phase 2 of the accreditation process, we believe that refined hydraulic modeling will need to be performed to better ascertain levee freeboard and erosion stability. We would recommend a full 2-Dimensional model that better utilizes the high resolution DEM data that is available. The model should also utilize refined flow data from the recommended hydrologic modeling of the watershed.

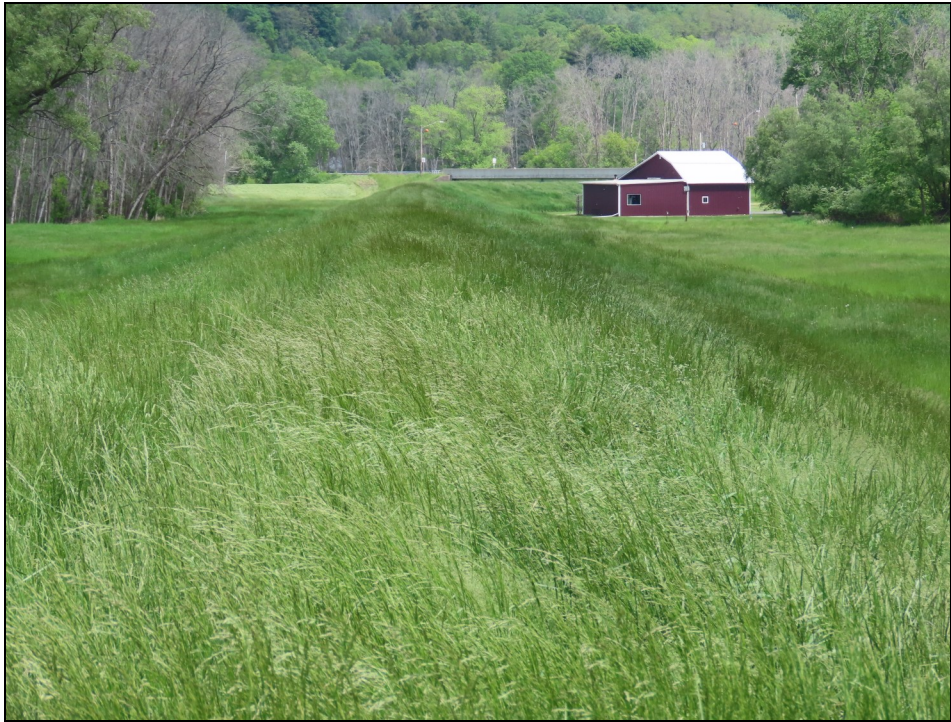
PHOTO 2

During the May 25th and 26th inspection the Catharine Creek Left Bank embankment crest was covered in tall grass, with the exception of the southern levee section where mowing was underway and the crest was freshly mowed. At the July 20th USACE's routine inspection all the levee reaches were mowed (Photos 2 & 9). Some minor ruts and tracks from vehicle access were noted on both the northern and southern sections of the Left Bank. No wet spots, cracking, or rodent holes were observed on the on the Catharine Creek Left and Right Banks or Shequaga Creek levee section crests.

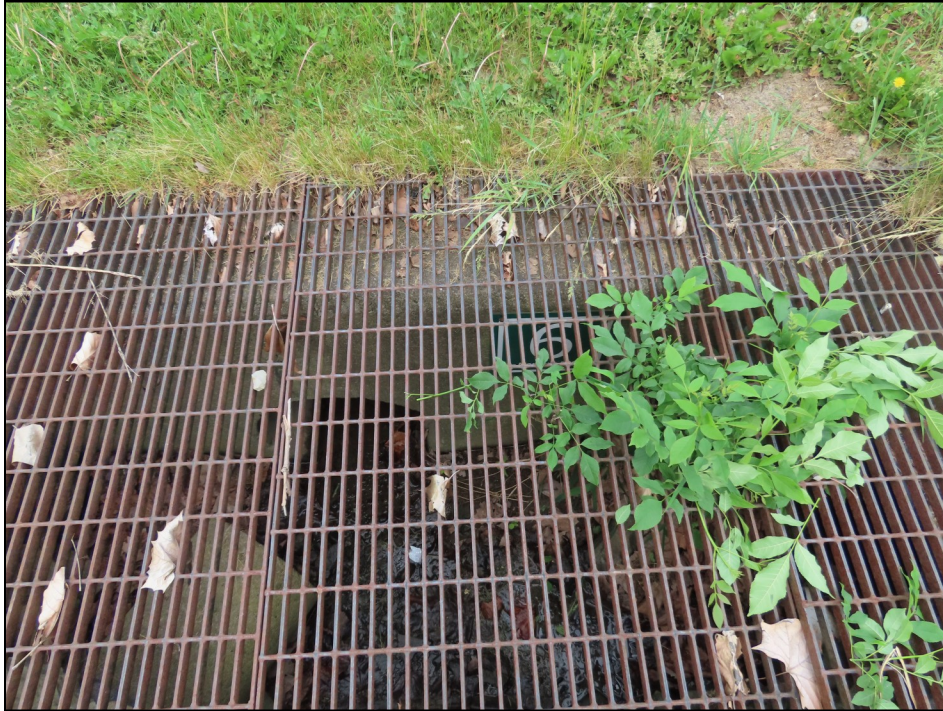
PHOTO 15

A total of six (6) numbered culverts provide interior drainage on the Catharine Creek Levee System. Culverts No's. 1, 2, 3, and 4 are located within the Left Bank Northern section, culvert No. 5 is located within the Left Bank Southern section, and culvert No. 6 is on the Right Bank Ring levee. All of the numbered culverts except for No. 5 are flap gates; culverts No's. 3, 4, and 6 measure 24-inch in diameter (Photos 1, 5, 6, & 17), and culvert No. 1 and 2 measure 36-inch in diameter (Photo 3). Culvert No. 5 also measures 24-inch in diameter it is controlled by a sluice gate manually actuated from the crest of the levee (Photos 10, 11, & 12). The inlet for culvert No. 6 is a shallow catch basin structure that is covered by a grate located near a sewage pump station (Photos 15 & 16). All flap gates were in working order and seemed to be regularly maintained.

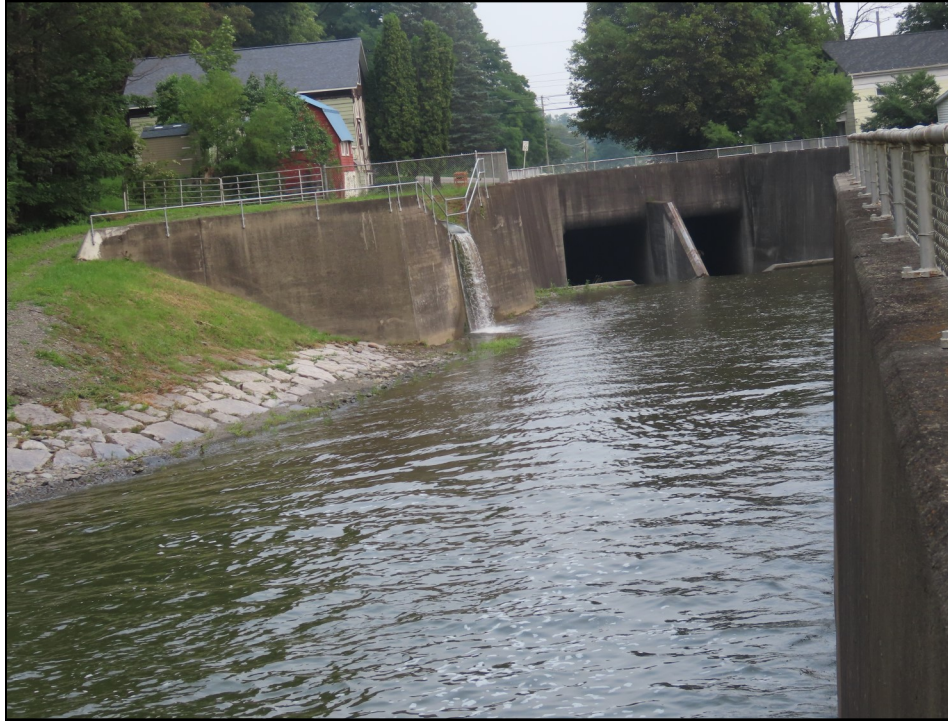
PHOTO 21

The Shequaga Creek channel begins at the base of the Shequaga Falls and is composed of a series of concrete structures including stilling basins and a twin-cell box culvert that extends beneath North Genesee Street (Photos 21 & 26). Beyond the concrete structures the Shequaga Creek is bound on the right side by an earthen levee and the crest of the levee is grass covered (Photos 28 & 33). A few rodent holes were observed along the crest (Photo 29). No wet spots, depressions, or cracks were observed.

One of several flap gates on the stilling basin providing drainage from behind the landside of the wall.

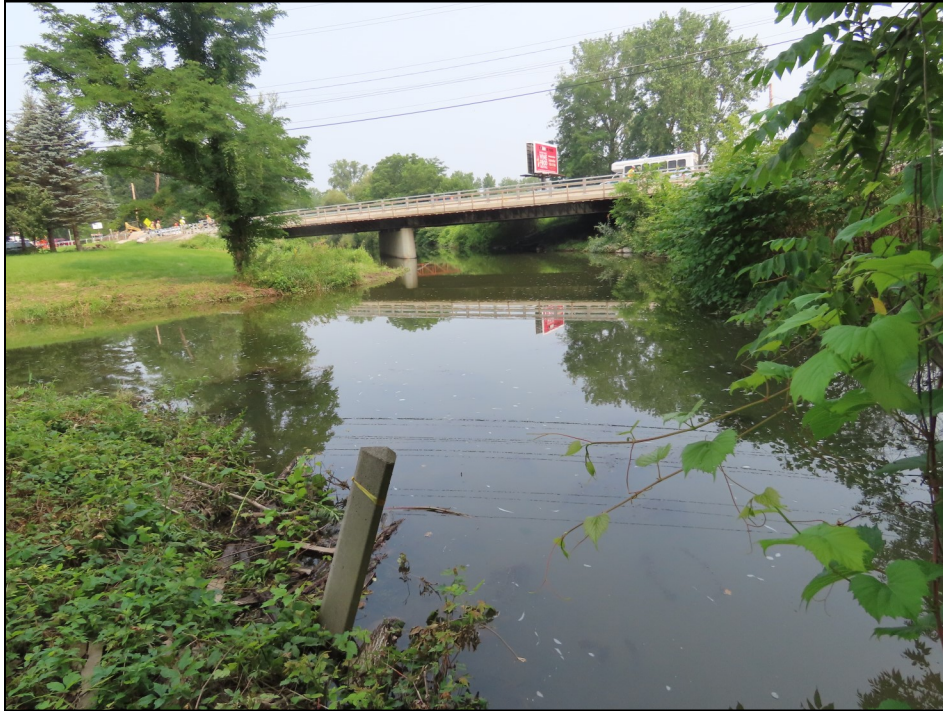
PHOTO 33

the earthen embankment meets the culvert outlet structure. The abandoned railroad bridge is the only creek crossing point between the twin-cell box culvert upstream and the end of the levee downstream (Photo 33) at Henry Street.

Note bridge in background is Catharine Street Bridge.
